MICHIGAN STAINED GLASS CENSUS FORM A: Building Data and Location of Windows

Name of Building: ST. CHARLES CHURCH

Address of Building: 8109 SWAN CREEK RD. NEWPORT, MI 48166
number street city state zip code

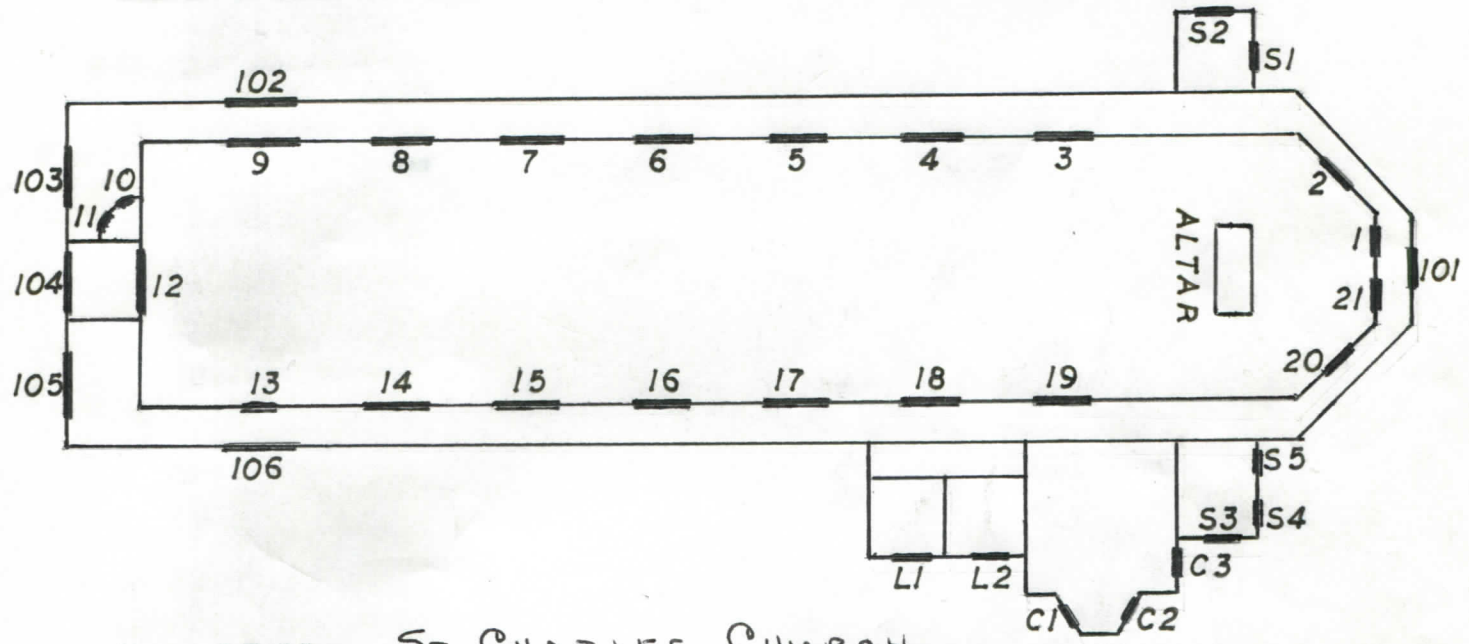
SKETCH OF BUILDING FLOOR PLAN: (Locate and number each window on plan. See Page 3 of instructions)

It is known from parish records that of the nineteen large stained glass windows in the church, seventeen were replaced in 1945/46 and that two (No's. 1 and 21) were walled over on the inside. One small round window (No. 101) was also covered.

In 1981 an addition was made to the church to provide rest rooms and access for the handicapped. Unfortunately, the design chosen for the roof on the addition was such that most of window No. 18 was blocked. A subsequent addition for a chapel effectively blocked window No. 19. All five blocked windows (No's. 1, 18, 19, 21 and 101) are included in this report because there is still hope that they may someday be restored. Window No. 104 was removed from over the main entrance and replaced with a statue. This window is stored on site.

Windows numbered 9, 10, 11, 12, 102 and 106 were not replaced in 1945.46 and are thought to be originals dating from 1882. Also windows numbered 1, 21 and 101, though now walled over, may date from church construction.

Windows C1, C2 and C3 in the chapel contain colored glass but were not photographed. Windows L1 and L2 are frosted glass in the restrooms and windows S1 thru S5 are plain glass and located in the sacristies.
